# STEELEMAN INSPECTIONS, L.L.C.

## Inspection Report

**Property Address:**  
1128 Daikin St.  
Lansing MI 48912

<b>Date:</b> 12/13/2019	<b>Time:</b> 12:00 PM	<b>Report ID:</b>
<b>Property:</b> 1128 Daikin St. Lansing MI 48912	<b>Customer:</b> Tim Baise	<b>Real Estate Professional:</b>

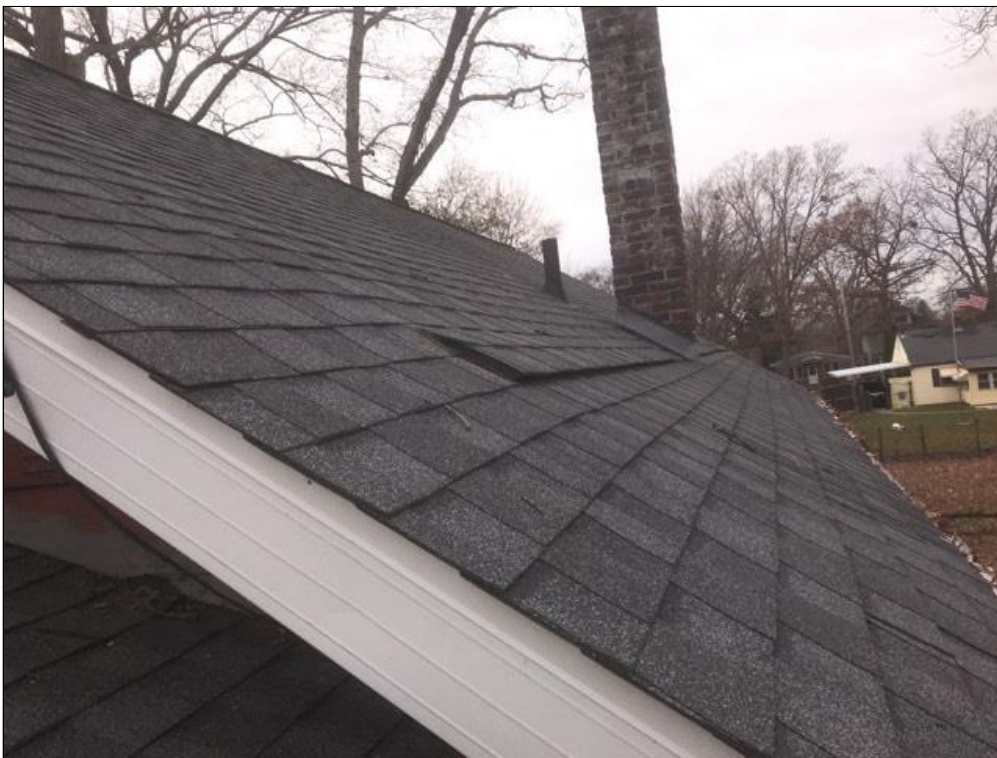
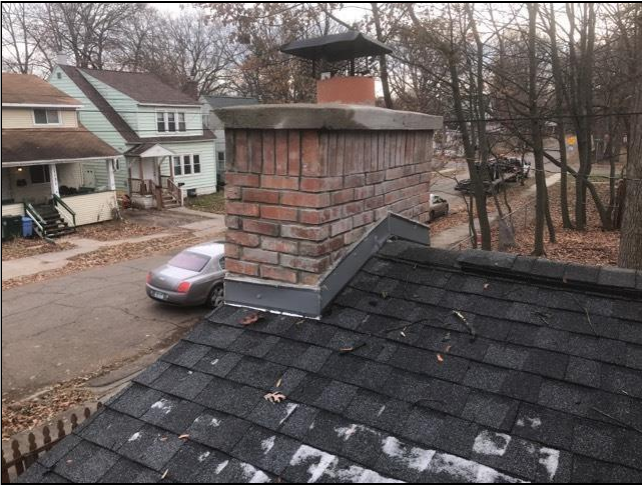
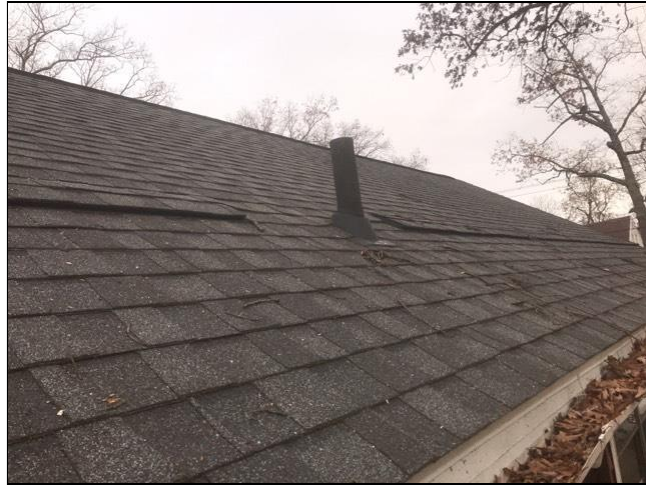
**1.0** #1-3 New roof overall appears to be intact with no leaking observed.

1.0 Item 1(Picture) roof overview

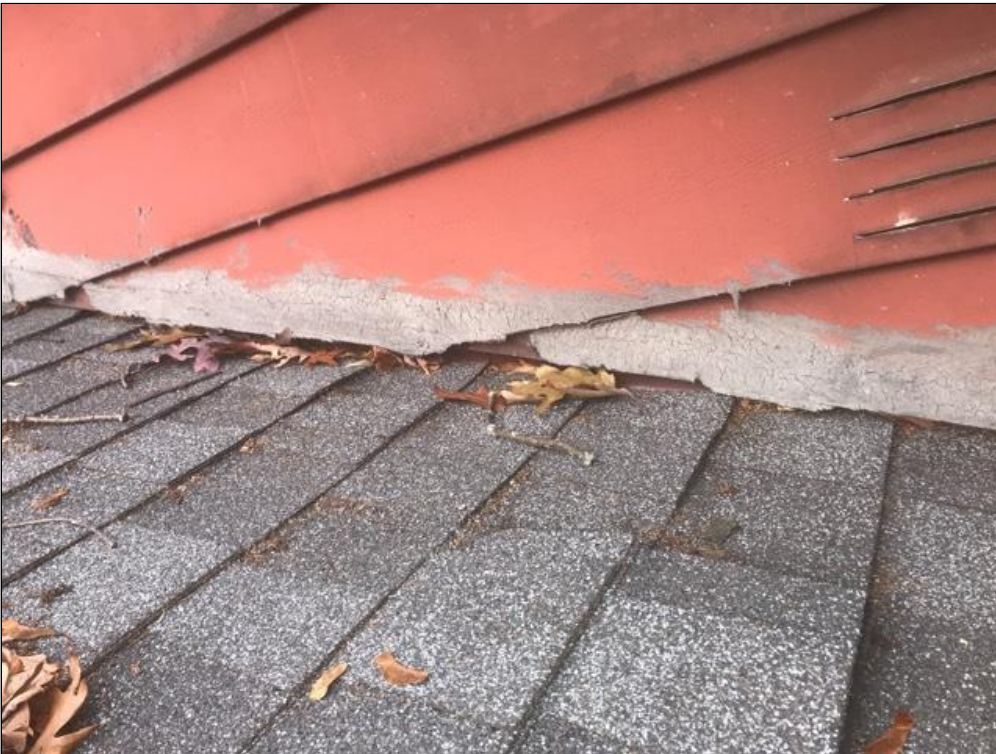
1.1 #1-2 Flashing was not observed, but no leaking was apparent directly under step flashed areas.

1.1 Item 1(Picture) flashing at gable not visible

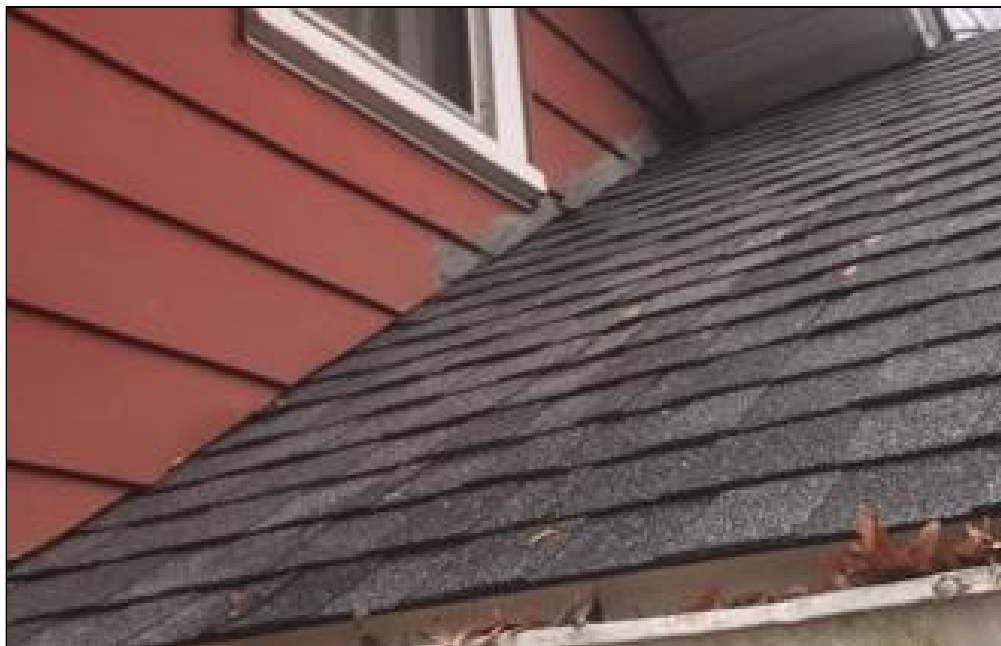
1.1 Item 2(Picture) no flashing observed

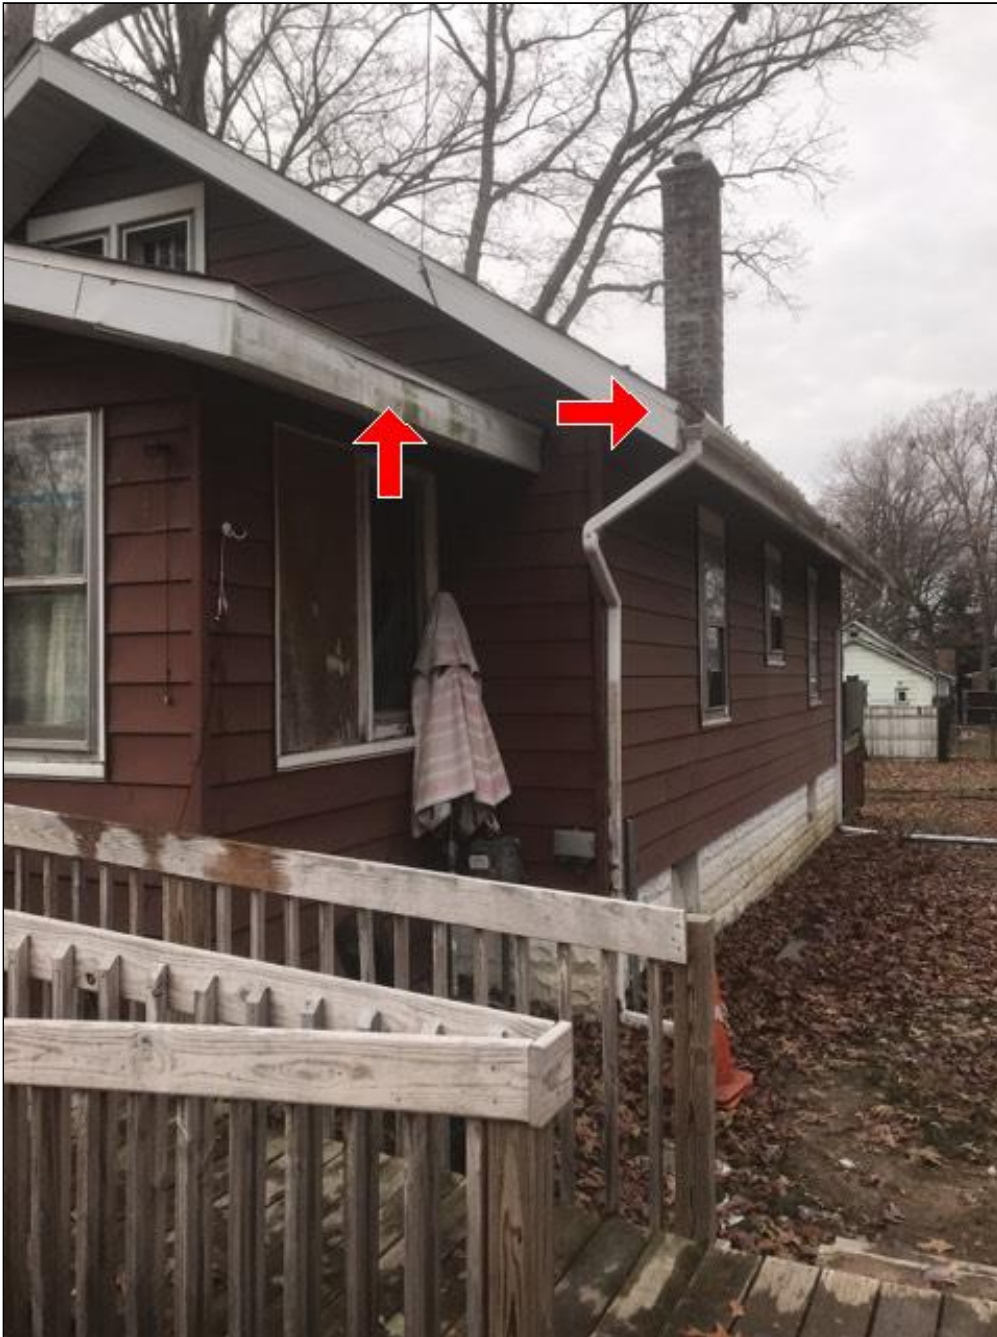
**1.3** #1-2 Gutters around the perimeter were damaged/missing pieces and moisture intrusion into the house is likely contributing to an increased elevated humidity level which is likely causing associated issues/problems experienced by the owner.

1.3 Item 1(Picture) gutter missing/damaged

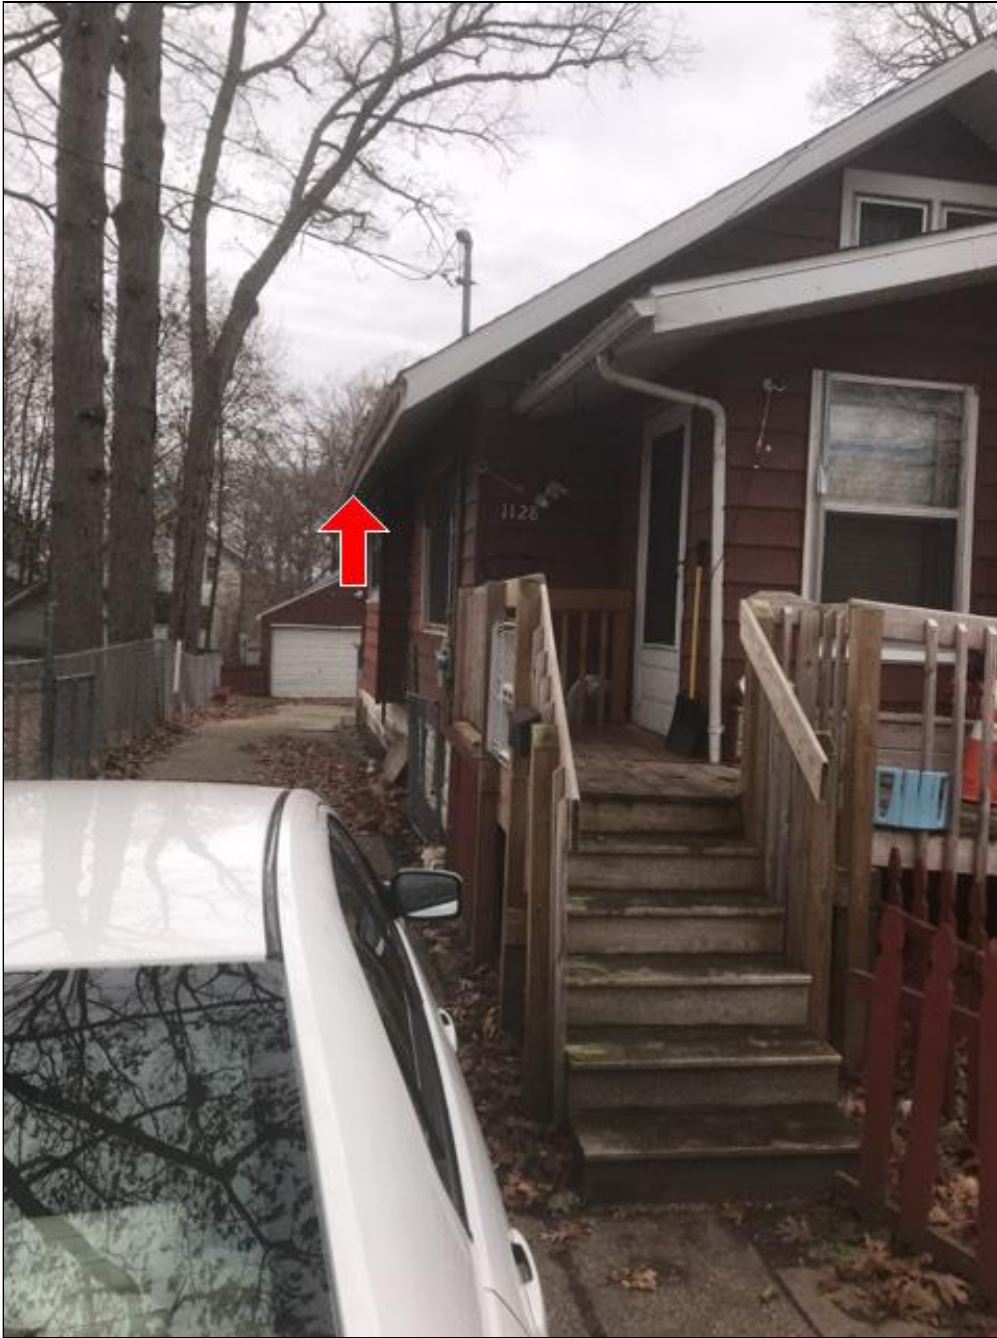
### 1.3 Item 2(Picture) gutters missing/damaged

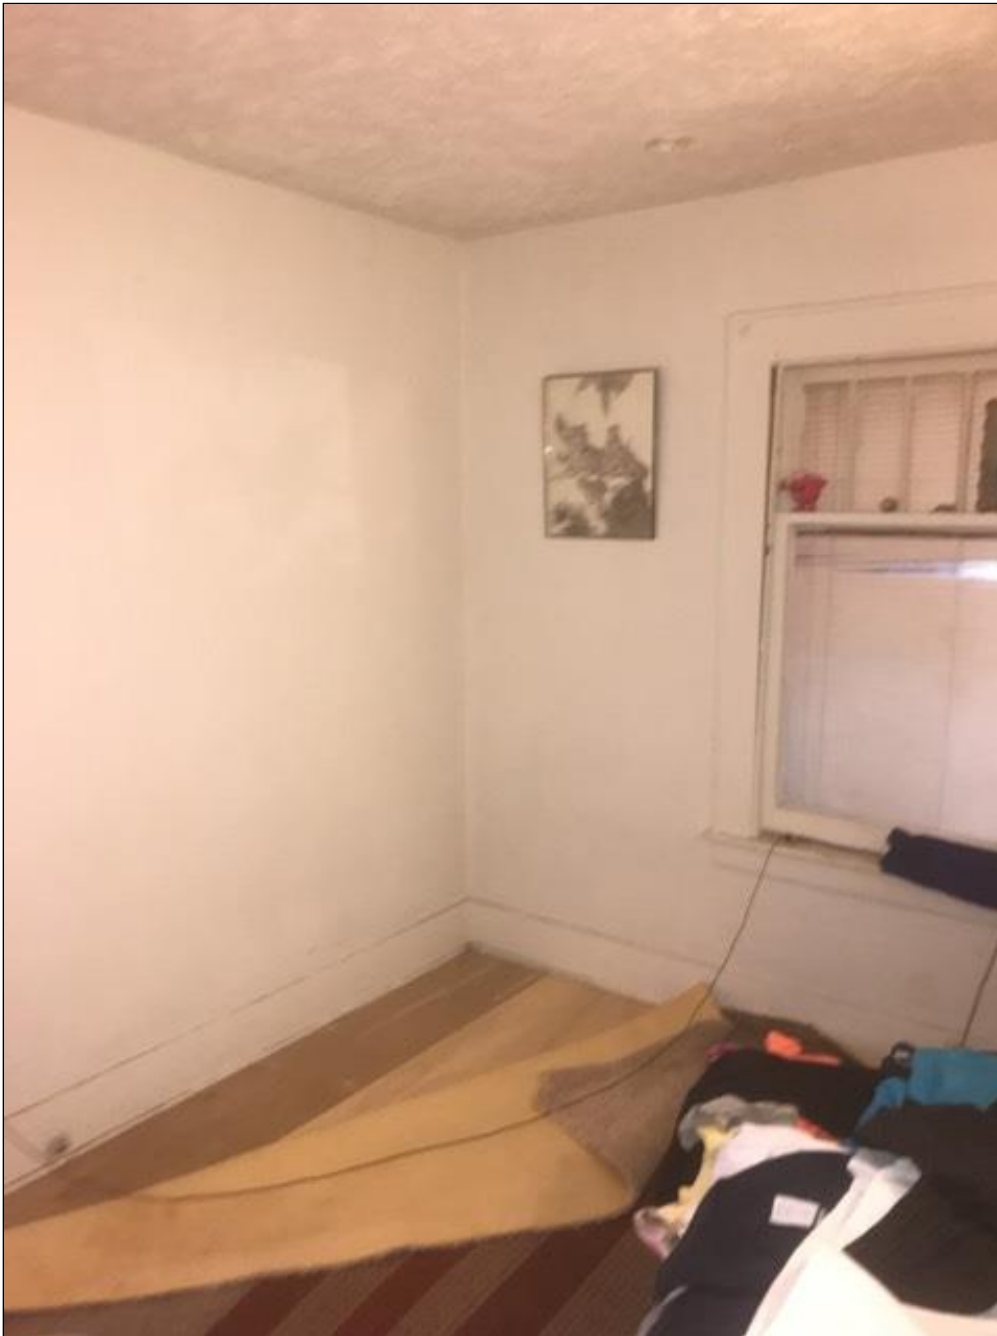
4.1 Item 1(Picture) front bedroom

**4.1** #1-3 Various staining is present from prior interior condensation. Owner has said that the home has experienced heavy interior moisture levels within the last year that was never an issue in the past. Review of gutters and basement indicates likely source as failed gutters and basement water intrusion, along with hvac distribution through out the entire home. This is turn elevated interior humidity causing various problems such as possible mold/mildew and various areas raining condensation moisture from above. No mold testing was ordered.

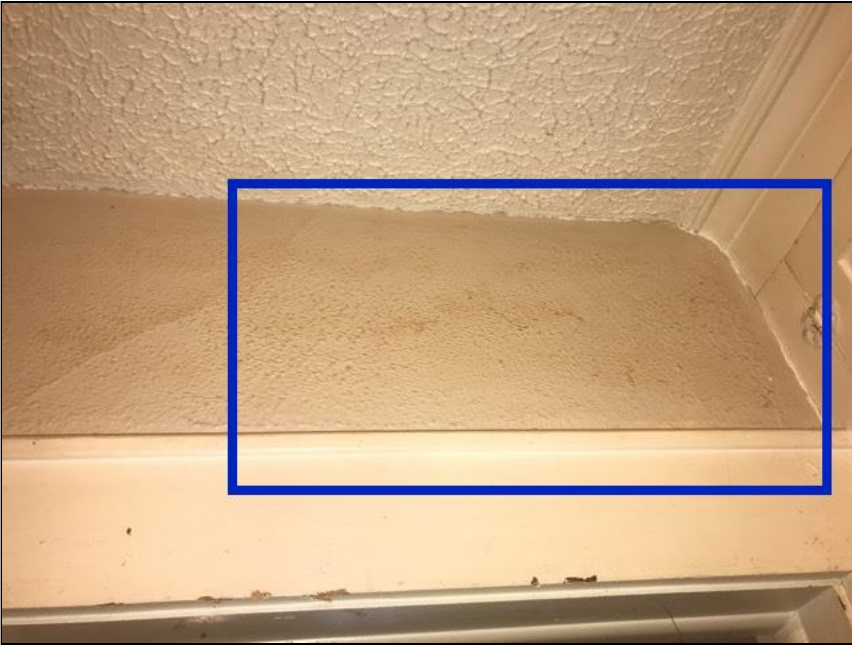
4.1 Item 2(Picture) prior moisture staining

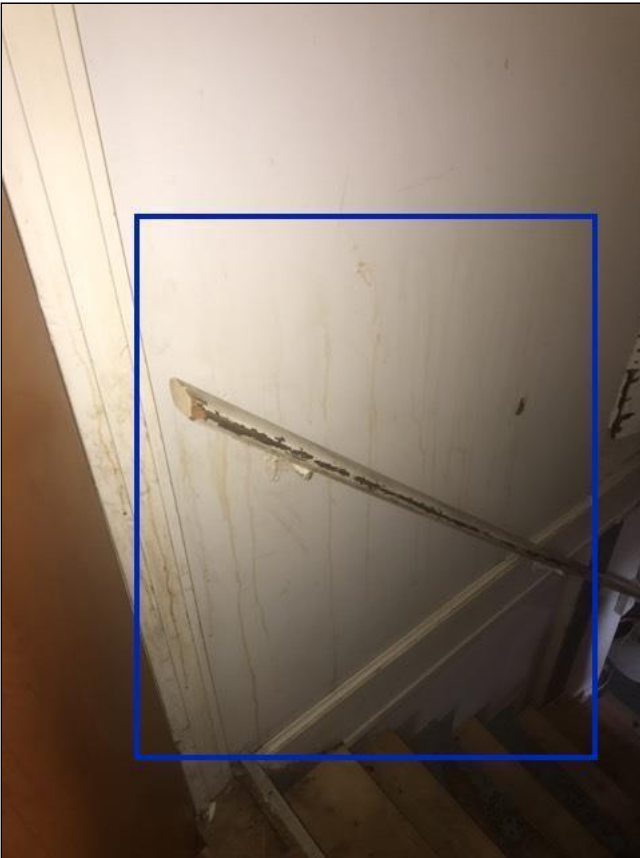
4.1 Item 3(Picture) wall to basement staining

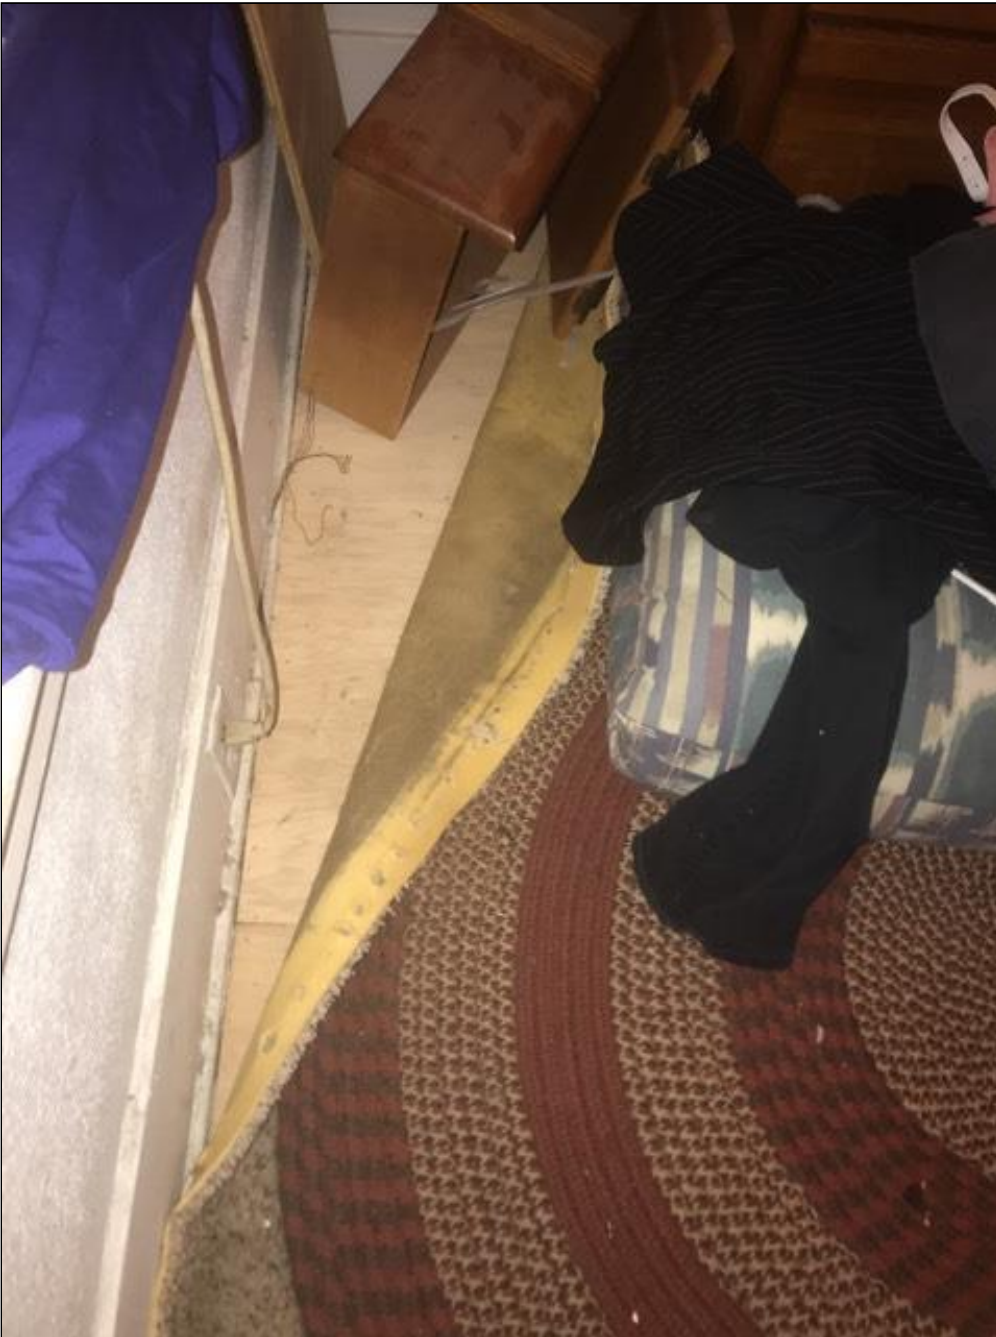
4.2 Item 1(Picture) carpet

**4.2 #1** Various carpets/floors are stained. Owner has said that floor coverings have deteriorated rapidly since interior elevated moisture levels causing mold/mildew/etc. Current high moisture levels were not observed. No mold testing was ordered.

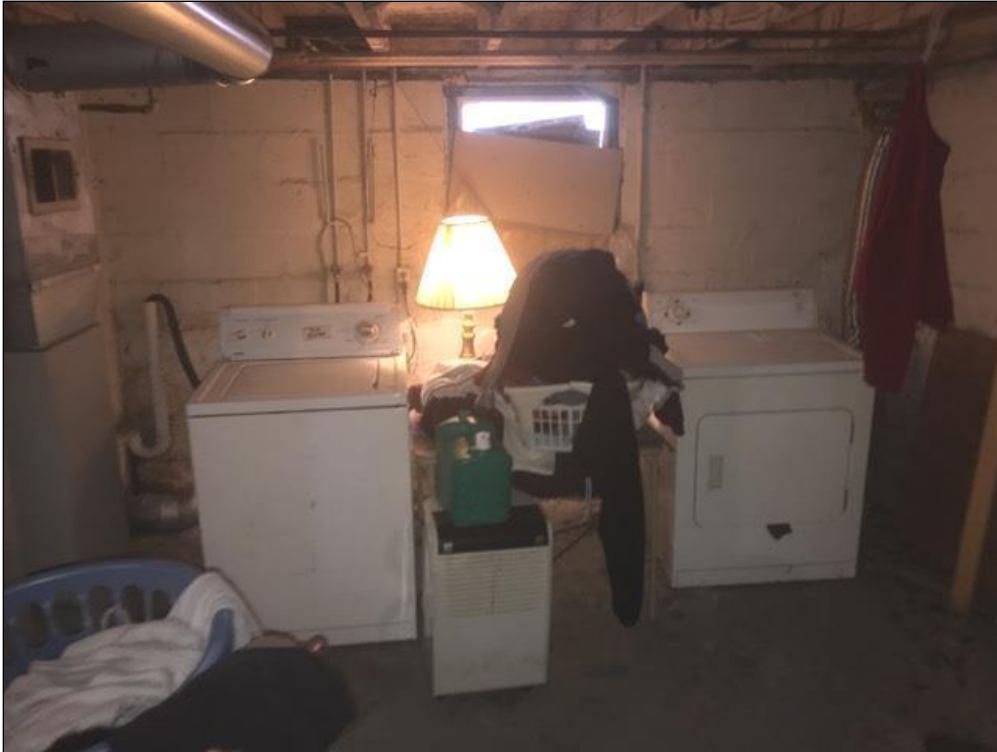
**5.0** #1-6 Basement has various water intrusion/staining and current which are allowing moisture intrusion. Owner has stated that the moisture intrusion worsened after the roof was replaced which left the gutters in disrepair. #7-8 HVAC asbestos covered ducts have been recently deteriorated according to the owner and possible mold attached is visible.

5.0 Item 1(Picture) basement water intrusion area

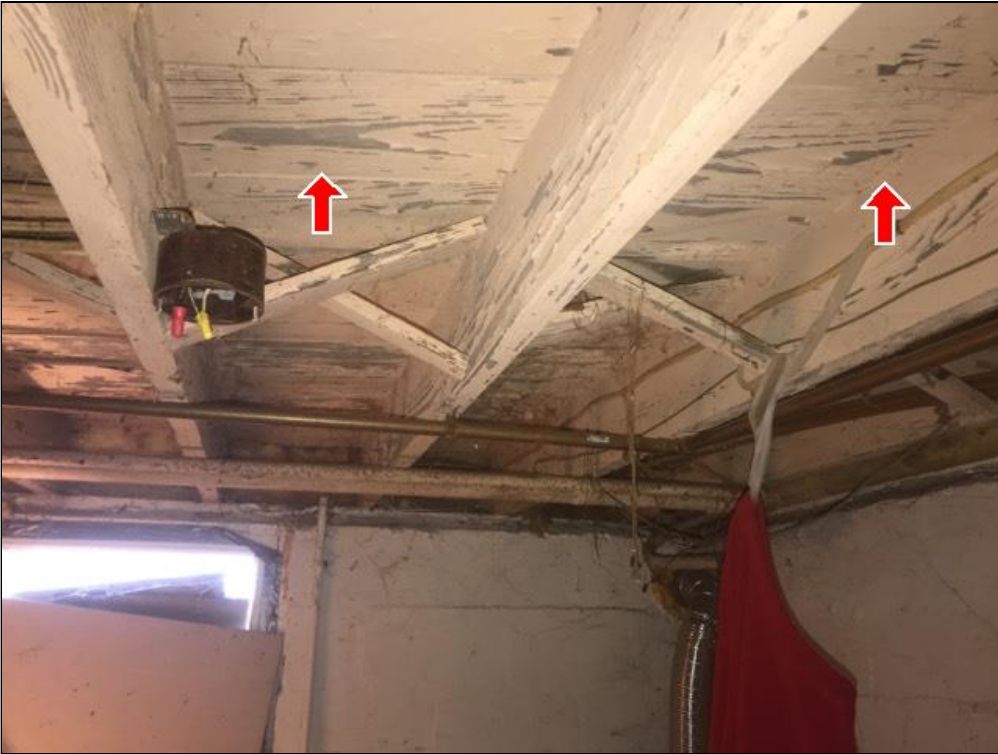
5.0 Item 3(Picture) peeling paint from condensation

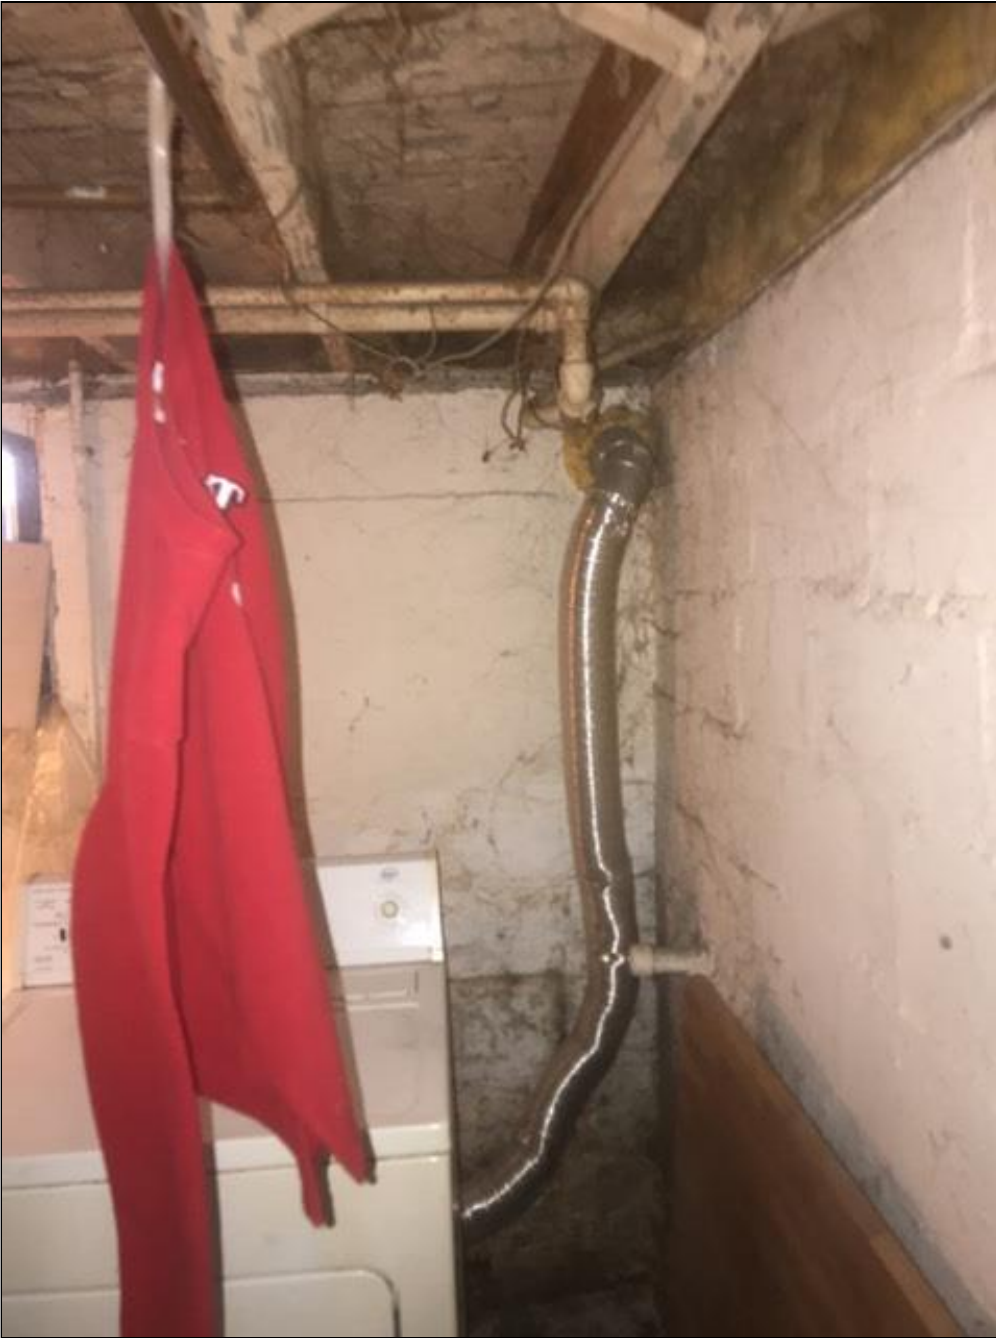
5.0 Item 4(Picture) water infiltration area

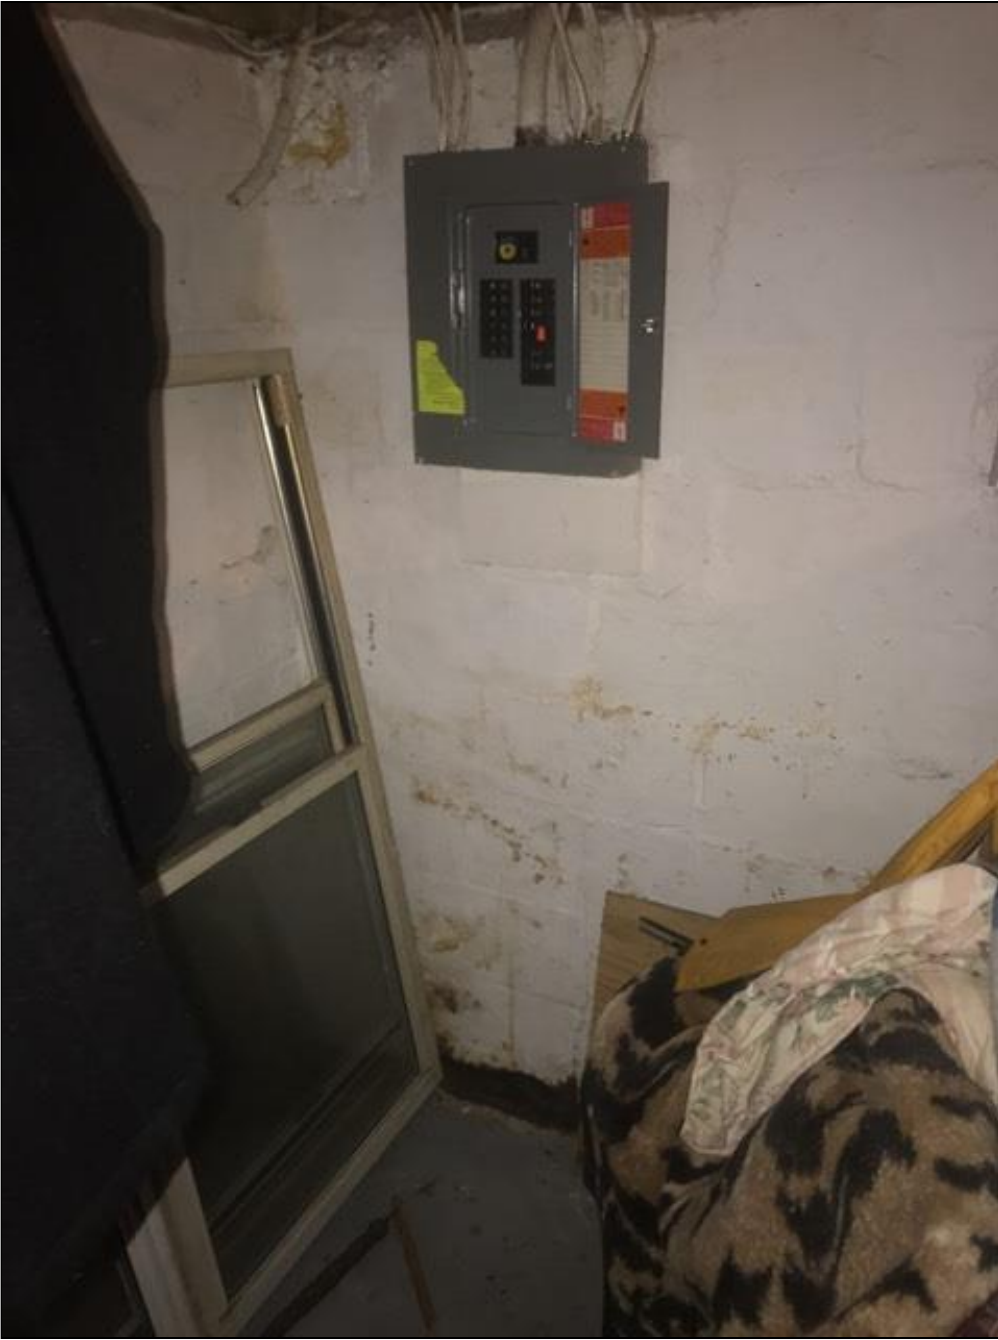
5.0 Item 6(Picture) basement wall staining

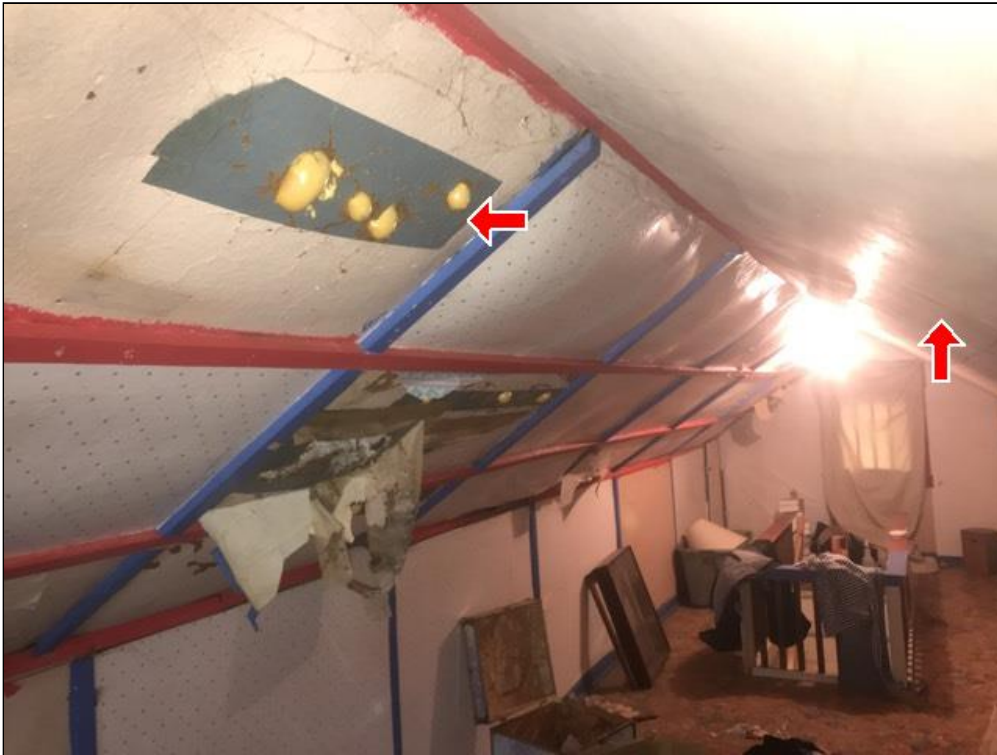
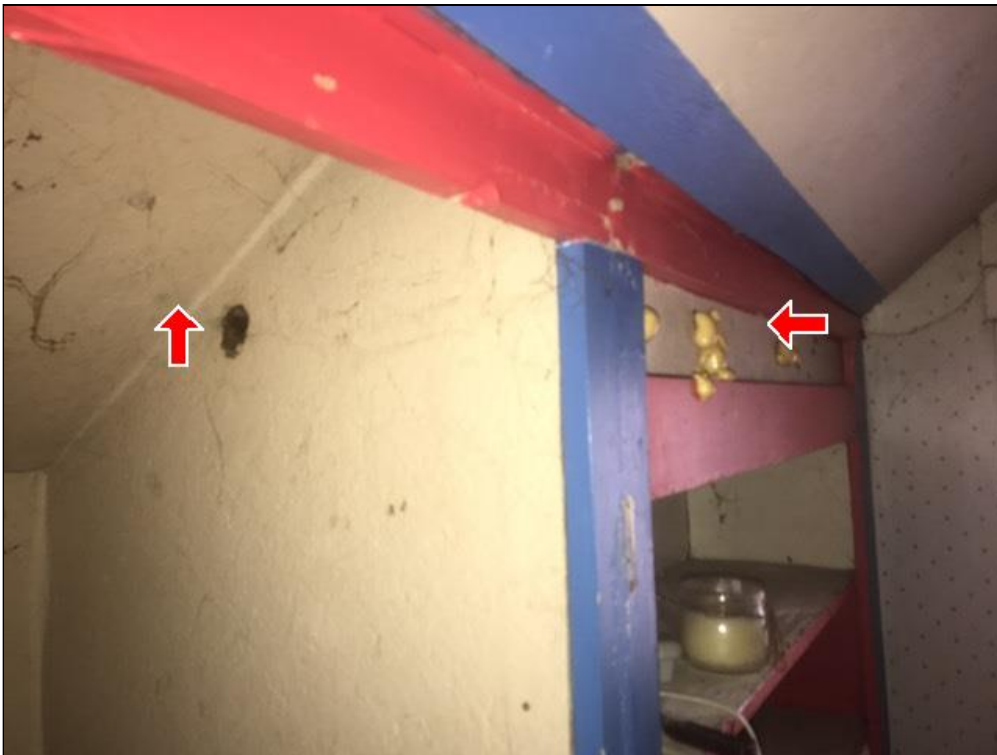
**5.5** #1-3 Attic has finished cathedral ceilings with insulation filling cavities. Currently proper ventilation is not possible as roof structure rafter cavities are filled with insulation. Most of the attic roof structure is not accessible.

5.5 Item 1(Picture) attic ceiling

5.5 Item 2(Picture) attic ceiling

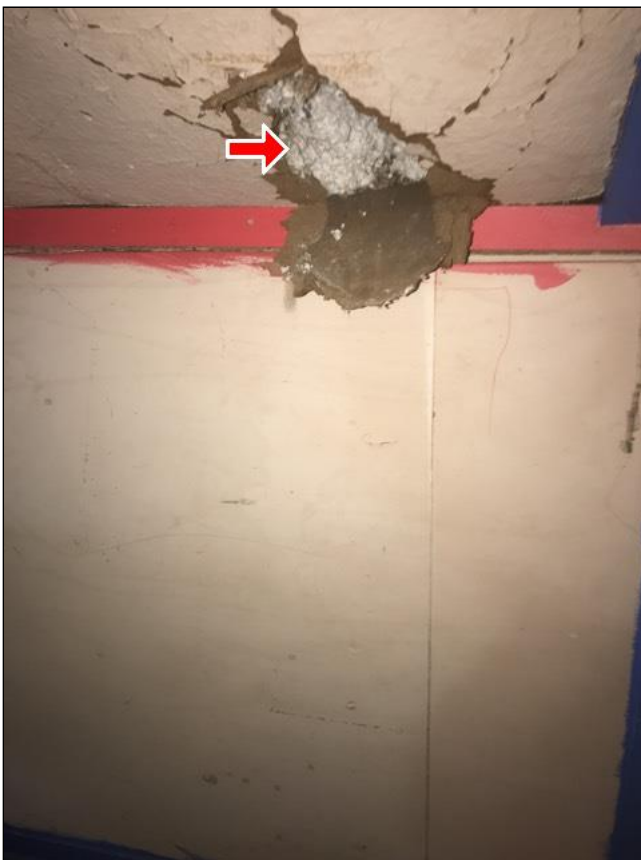
5.5 Item 3(Picture) attic ceiling insulation

**9.0** attic insulation is improperly clogging rafter cavities.

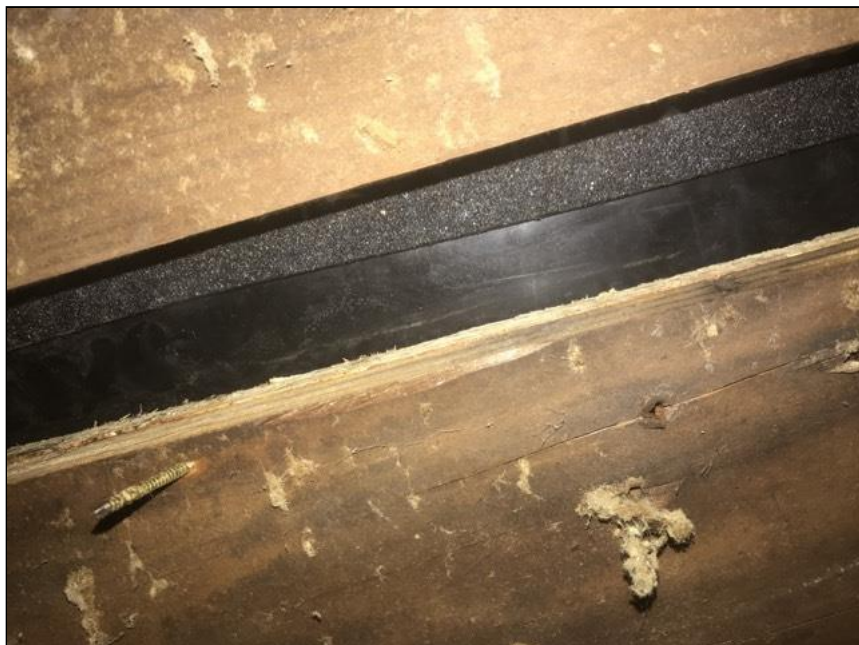
**9.3** #1 Shingle over intake vent along with ridge vent is present. However this system is not currently functional as the lower intake and upper exhaust vent do not connect. #2 Blocked rafter cavities to lower level. The attic cathedral ceiling has each cavity full of foam insulation. Proper ventilation is impossible in its current configuration. On cathedral ceilings, each rafter cavity needs to have baffles to allow ventilation to flow from the lower intake vents to the upper exhaust ridge vent. In its current configuration, adequate ventilation is not possible.

9.3 Item 1(Picture) shingle over intake vent

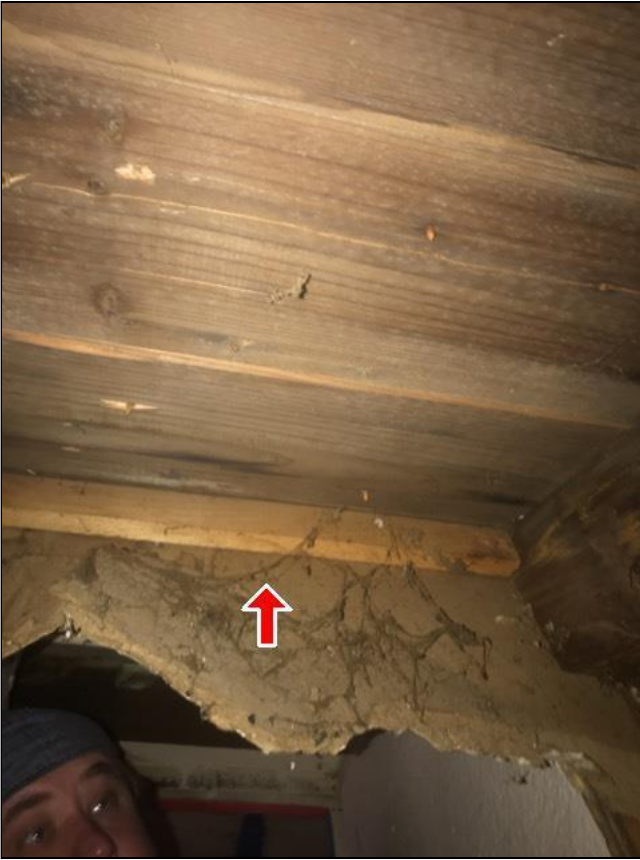
9.3 Item 2(Picture) blocked rafter cavity
